**The Use of Water Sensors to Examine Water Chemistry
Related to Marcellus Shale Natural Gas Development**

A Senior Thesis in Geosciences

Spring 2013

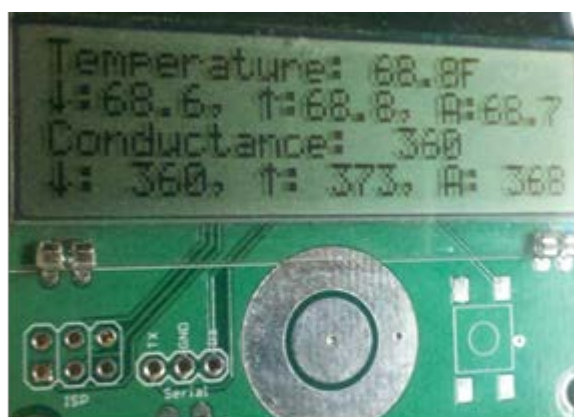
Figure 2-3. CATTfish screen readout with temperature values followed by conductance values.

The temperature values are read in order as current temperature, temperature minimum (since installation) after the down arrow (↓), temperature maximum after the up arrow (↑), and average temperature after the “A”. The EC values follow the same pattern: current EC, EC minimum (after ↓), EC maximum (after ↑), and average EC (after “A”). Time should be recorded along with the current and maximum conductance values and convert EC to TDS using equation (2). The sensor is designed to help homeowners discover a jump in TDS (such as above 700 $\mu\text{S}/\text{cm}$) that might be a cause for concern.

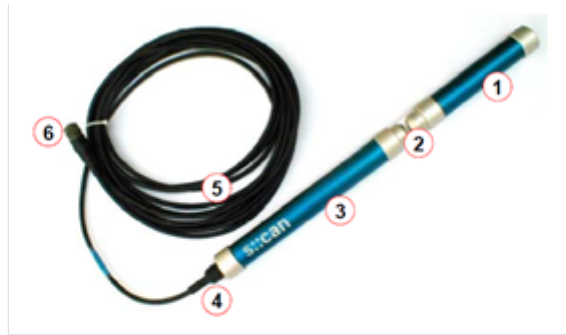
Figure 2-4. S::can spectro::lyser device parts. (1) Probe’s housing (emitter side); (2) Measuring section; (3) Probe’s Housing (detector side); (4) Cable gland; (5) Probe cable; (6) Connector.

The sensor, also called a probe, has a measuring section, stainless steel housing on both sides of the measuring section, and a cable that connects to the con::nect. The measuring section is 35 mm wide and when taking a measurement, shoots a light beam across from the xenon light emitter to the detector.

In order to operate the s::can spectro::lyser, the following must be deployed: the sensor, a control center for the electronics called the “con::nect”, a computer, and a cleaning system. The spectro::lyser sensor’s components, without the cleaner, are shown in figure 2-4.

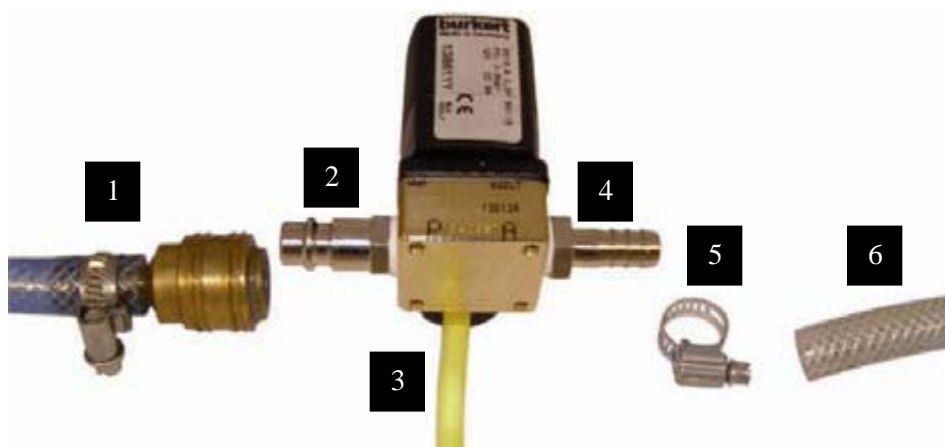
Figure 2-6. Cleaning valve and connections to it. (1) Plastic air hose with adapter fitting, (2) Larger connection side of the cleaning valve that connects to the plastic air hose, (3) Yellow tubing that connects to the connection, (4) Thinner connection side of the cleaning valve that connects to the vinyl tubing, (5) Hose clamp, and (6) 3/8 inch vinyl tubing.

Since this sensor was designed to be deployed long term in various locations such as water treatment plants or natural waterways, sediment may sometimes obscure the lenses of the measuring section. Therefore, a cleaning system is part of the system. The components that come along with the sensor are a cleaning valve with yellow power cord attached and a 3/8 inch plastic air hose that is UV and ozone resistant (figure 2-6).

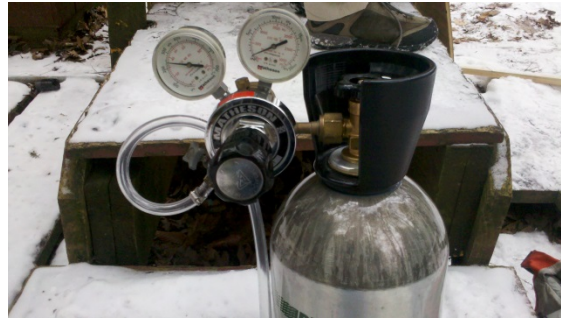
Figure 2-7. CO₂ tank with regulator and 3/8 inch vinyl tubing connected.

As part of the cleaning system, compressed air is required to clean the spectrolyser lenses. In this application, I used a 20 pound CO₂ tank with a regulator, which was purchased separately from the spectrolyser. The other end of the vinyl tubing should connect to this as seen in figure 2-7 with a hose clamp.

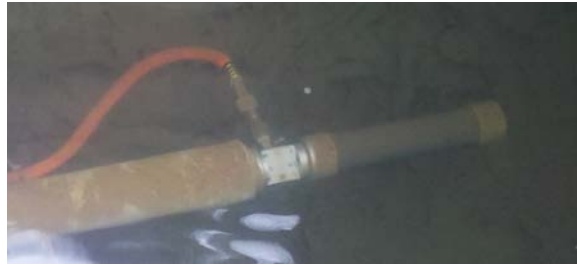
Figure 2-8. Submerged spectro::lyser with 3/8 inch air hose screwed in.

Teflon plumbers tape is used to seal all connections. The cleaning of the spectro::lyser is accomplished by a compressed air blast directly to the measurement section.

The other end of the air hose screws into the probe on the underside of the measuring section as seen in figure 2-8.

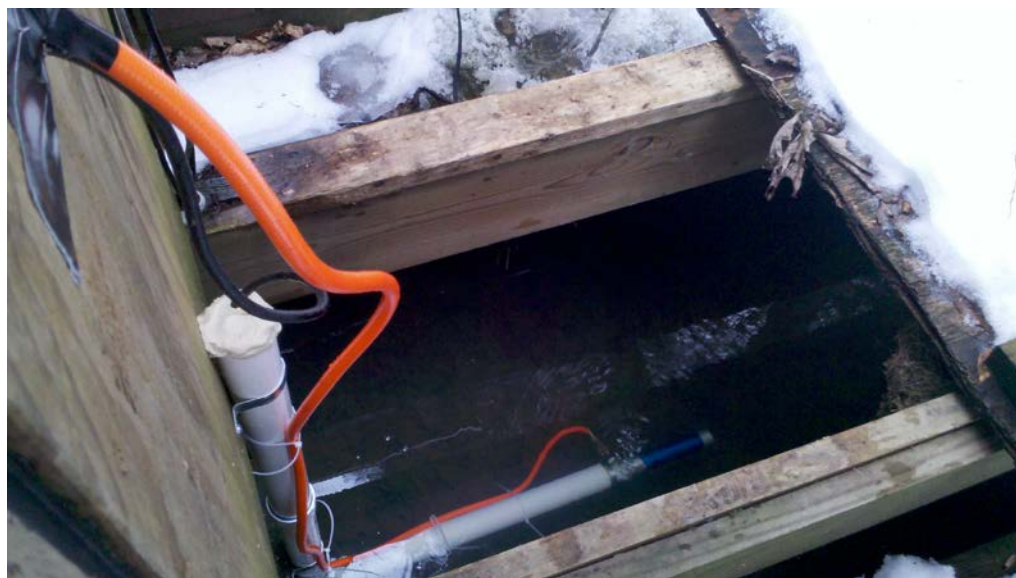
Figure 2-9. Picture of spectro::lyser setup at Shale Hills Critical Zone Observatory.

To set up the sensor, we first assembled and cemented the PVC pipes together and threaded the spectro::lyser's cable through the pipes. We then secured the sensor in place (with the measuring section only slightly out of the tubing and facing up) with plumber's putty. Next, we attached the cleaning system plastic air hose to the sensor and zip-tied the hose up around the piping. We then threaded the sensor's cable and this hose into the enclosure to attach to the connect and cleaning valve. Our enclosure was a large wooden box built into the ground so we mounted the PVC piping directly against it. We mounted the piping with pipe clamps around it screwed into the wooden box, at the correct height so that the spectro::lyser was submerged by approximately ten centimeters. The assembly outside of the enclosure is shown in figure 2-9.

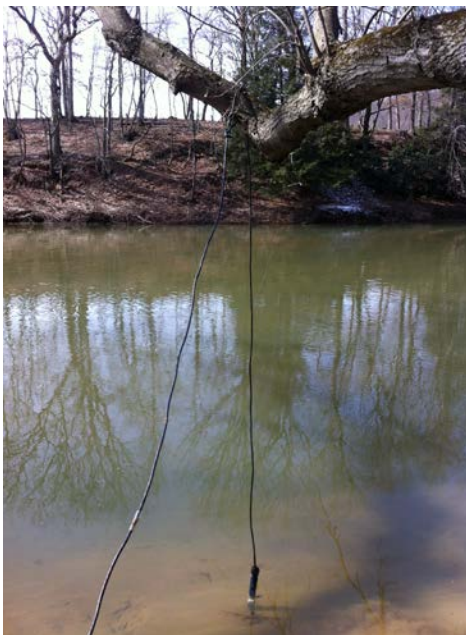
Figure 2-11. Picture of vertical deployment at Sampling Site 1, Two Lick Creek.

Sampling Site 1 is located on Two Lick Creek, approximately thirty meters upstream of the confluence with Blacklick Creek and about 200 meters below the point of disposal from the Josephine plant. When we observed the creeks, the discharge for Two Lick Creek was very low at Site 1 compared to the fast-moving Blacklick Creek, and sedimentation was observed to be occurring at the confluence. The spectro::lyser was suspended vertically in order avoid disturbing the fine silty sediment on the stream bank (Figure 2-11). This site was visited and measurements made on March 5, 2013.

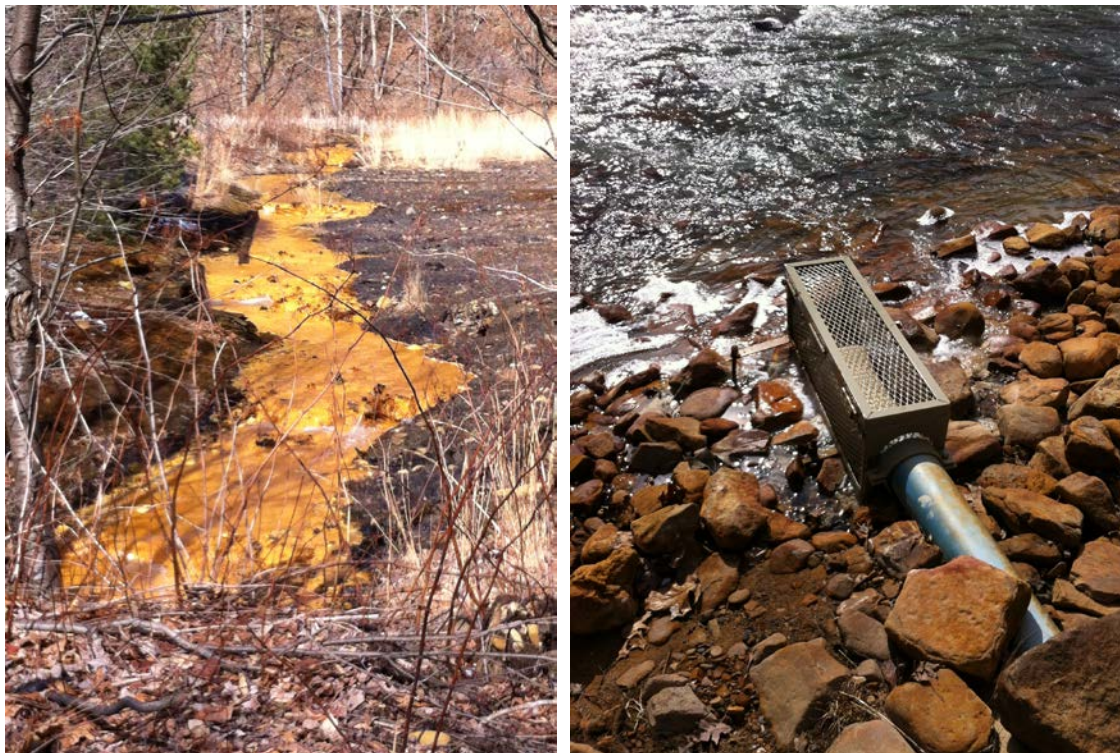
Figure 2-12. Pictures from around Sampling Site 4. (Left) Bright orange sediment; (Right) discharge pipe, likely from treatment facility.

Site 4 is located on Blacklick Creek approximately 50 meters upstream of the PA Brine Treatment Plant discharge. It was accessed via Ghost Town Trail on March 5. While walking to this location, visual observations of the facility discharge were made. There is a discharge pipe which likely drains from the treatment facility directly into the stream as well as two ponds with bright orange sediment, likely caused by acidic conditions, draining to the stream (Figure 2-12).

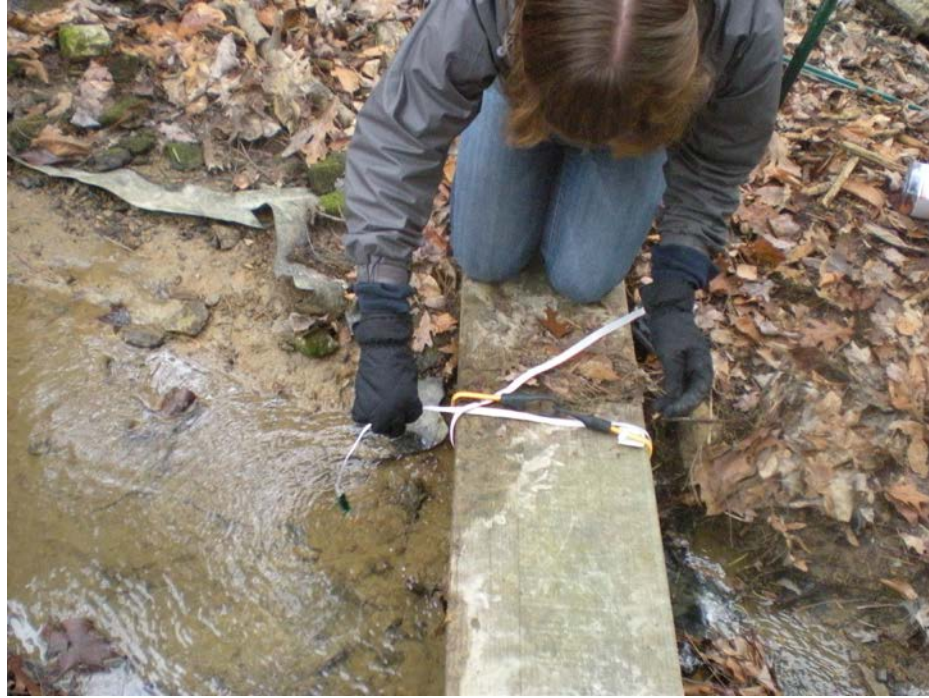
Figure 3-2. Shale Hills deployment of the WaterBot. A modification was made to allow the chip to be suspended freely in the water (i.e. not floating nor touching the stream bed).

The WaterBot was relatively simple to deploy and retrieve data from once the software was installed. One problem found was getting the chip to be suspended freely in the water, as seen in figure 3-2.

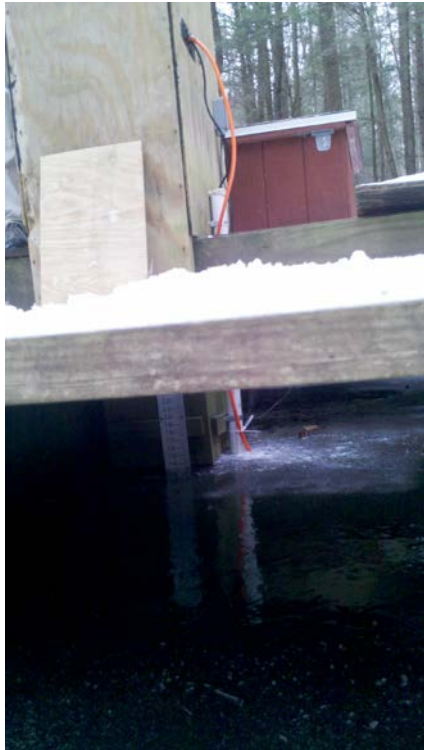
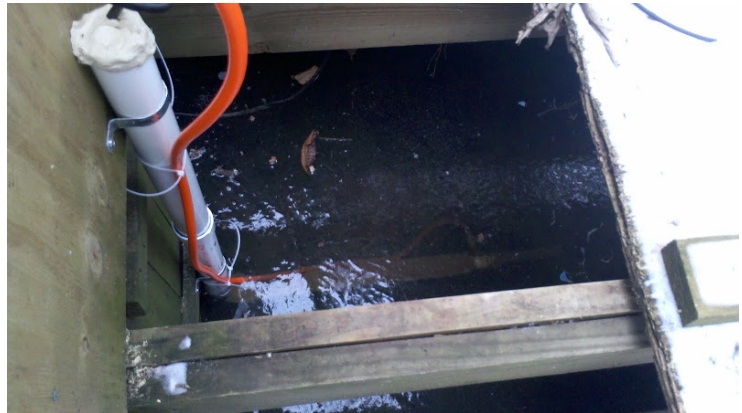
Figure 3-6. Spectrolyser photos in bad conditions; freezing temperatures (left) and a lot of sediment (above).

We had several deployment issues with the spectro::lyser. For example, the cleaning valve leaked so the CO_2 tank ran out halfway through deployment, we had difficulties with the software and this resulted in a gap in data, and the sensor did not respond well at all times in the stream, perhaps due to suspended sediments or the cold temperatures. Figure 3-6 shows the spectro::lyser after two weeks of the cleaning system not running at Shale Hills. Because the cleaning system malfunctioned, the sensor became covered in sediment. In addition, winter conditions resulted in the sensor being submerged under a layer of ice.

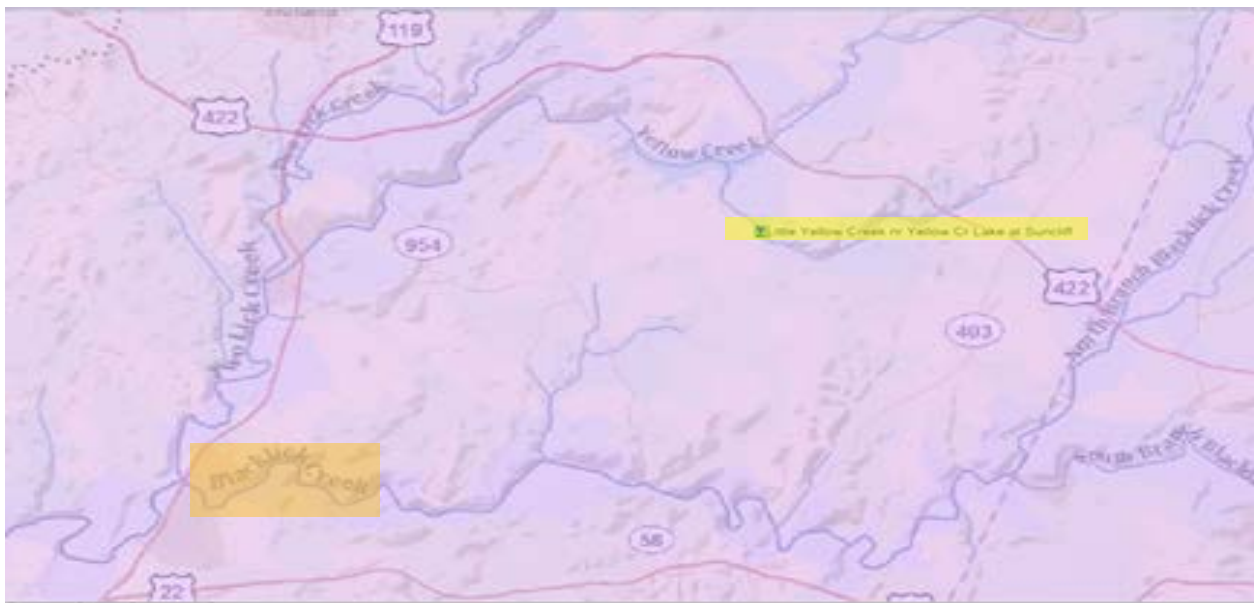
Little Yellow Creek is located north of Blacklick Creek, as seen in figure 3-13. Two Lick Creek flows into Yellow Creek which flows into Little Yellow Creek. Blacklick Creek flows into Two Lick Creek, farther south and upstream.

Figure 3-13. Little Yellow Creek's location (highlighted in yellow) in comparison to Blacklick Creek (highlighted in orange).
