Susquehanna Shale Hills CZO – Summary of Harrys Valley (HV) Well 1:

Harrys Valley Well (HV Well 1)
Susquehanna Shale Hills CZO

Core photo log, Images taken 08/28/15 and 9/2/15

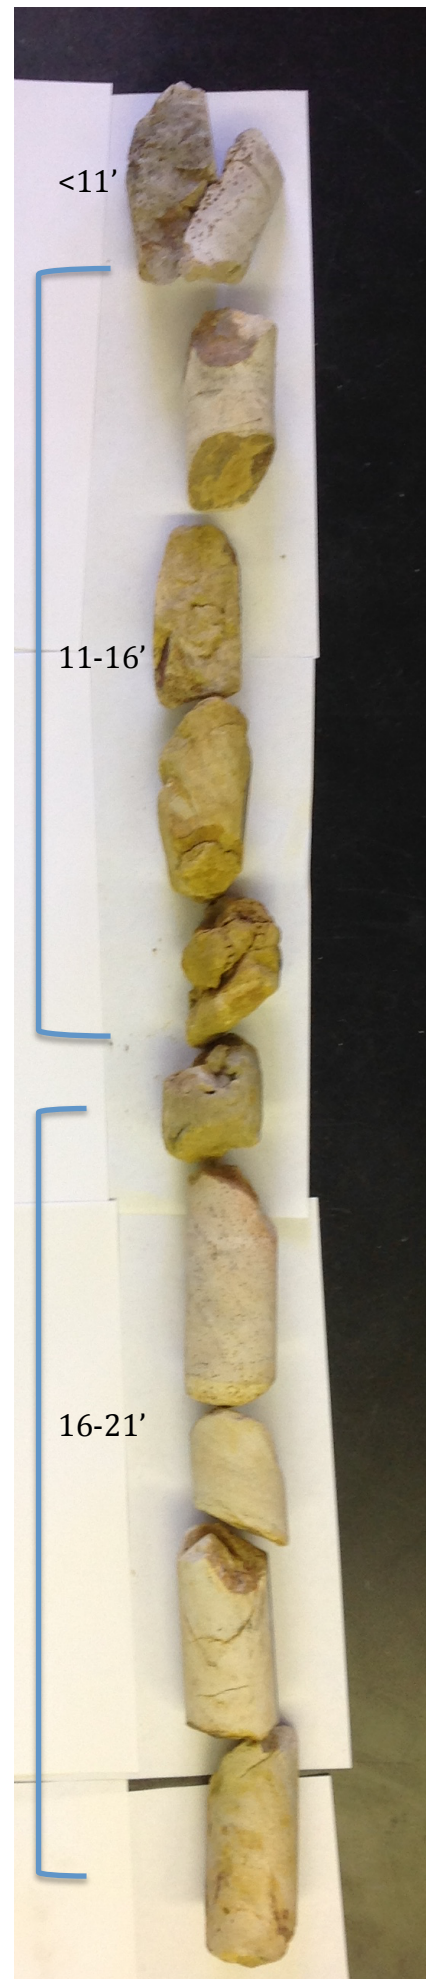
Run # 0

Depth Interval: Less than 11'

Sample Description: Light rose to grey in color. Sample split down the middle exposing grey interior. Outer portion of core contains dissolution pits with red-brown staining. Consists of mostly well-sorted, cemented quartz (grain size fU -fL; 125-250 μ , rounded grains). Top of core is oriented to the left. Blue line in Figure A is 8in.

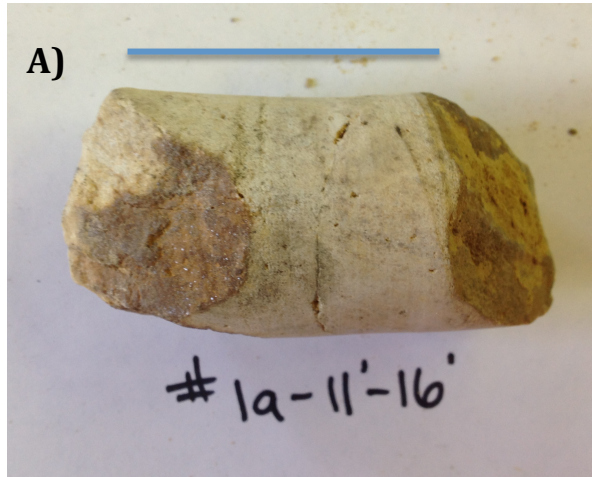
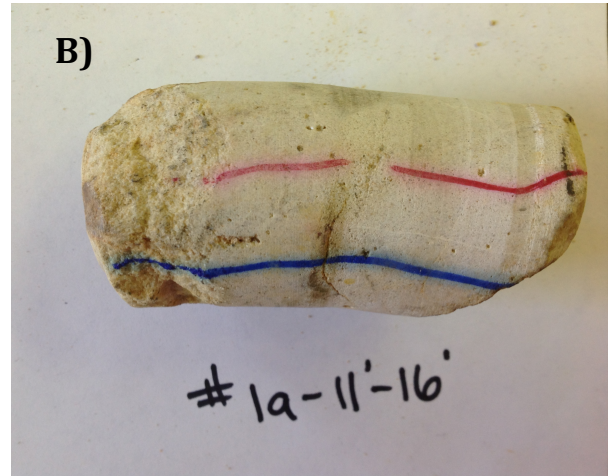
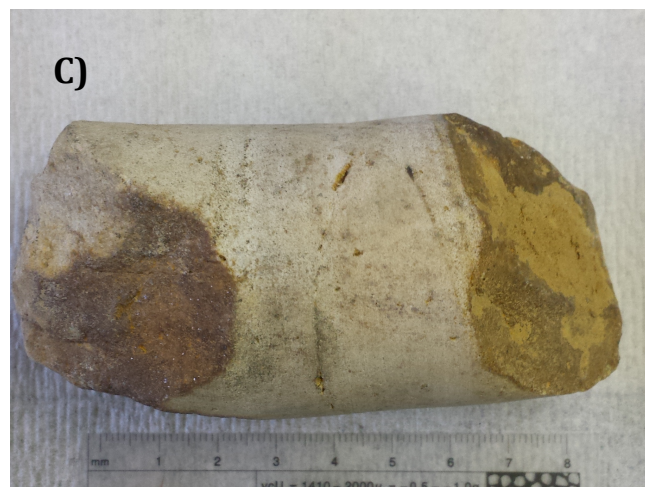
Run #1a

Sample Description: Light yellow to white in color with some brown/yellow staining. Well sorted and well cemented. Some subangular mU (350-500 μ) grains at top of sample. Small 0.3 in zone near bottom of sample with cL-mU quartz grains; majority of sample fU-fL. Minor dissolution pits. Blue line in figure A is 8 in. In figure B, red line is top, blue line is bottom. Figure C, is the core after 1 week of drying; ruler is in inches. All images are captured so top of core is to the left.

- 1a – Shallowest depth. Light yellow to white in color with some brown/yellow staining. Well sorted and well cemented.
- 1b – Deeper than 1a. Light yellow to white in color with some brown/yellow staining. Well sorted and well cemented. Some subangular mU (350-500 μ) grains at top of sample. Small 0.3 in zone near bottom of sample with cL-mU quartz grains; majority of sample fU-fL. Minor dissolution pits.

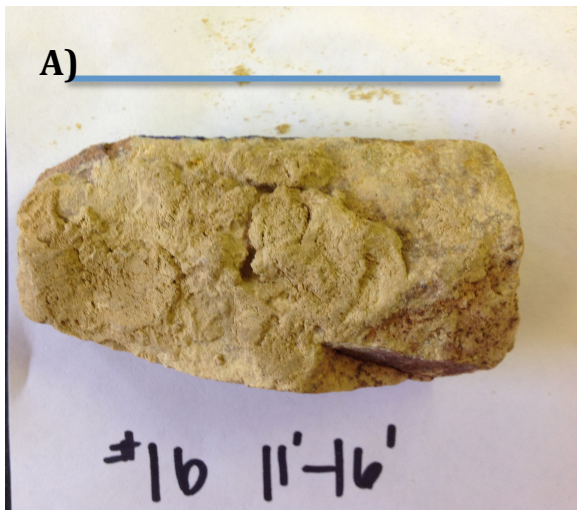
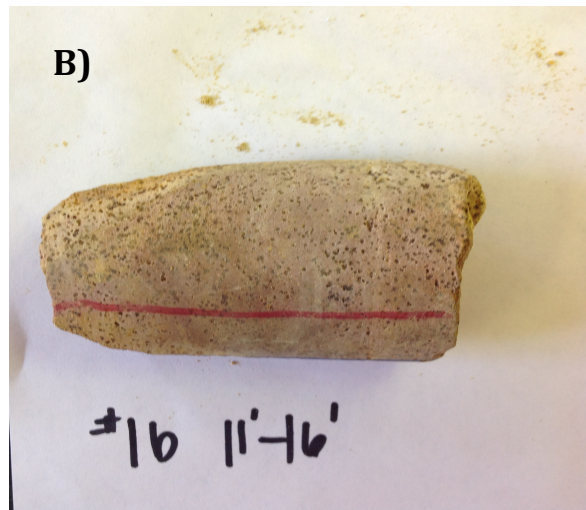
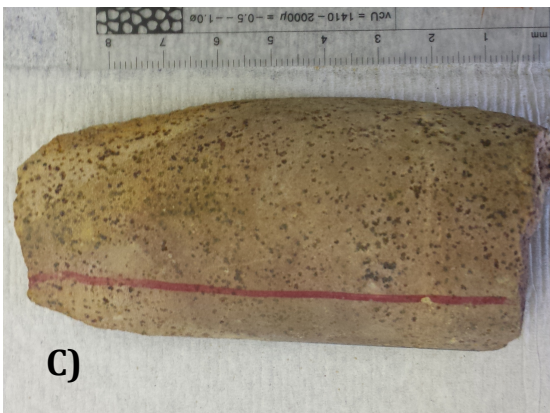
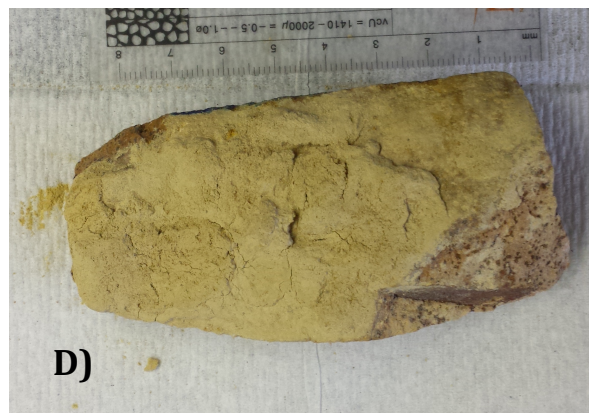
Run #1b

Sample Description: Yellow to rose/grey in color. Extensive dissolution pits on outer portion of sample (similar to Run#0 sample) with red staining inside the pits. cemented quartzite (fU-mL 177-350 μ in size). Blue line in Figure A is 8 in. Top of core is to the left. Figures C and D are after one week of drying; ruler is in inches

- 1c – Deeper than 1b. Yellow to rose/grey in color. Extensive dissolution pits on outer portion of sample (similar to Run#0 sample) with red staining inside the pits. cemented quartzite (fU-mL 177-350 μ in size).

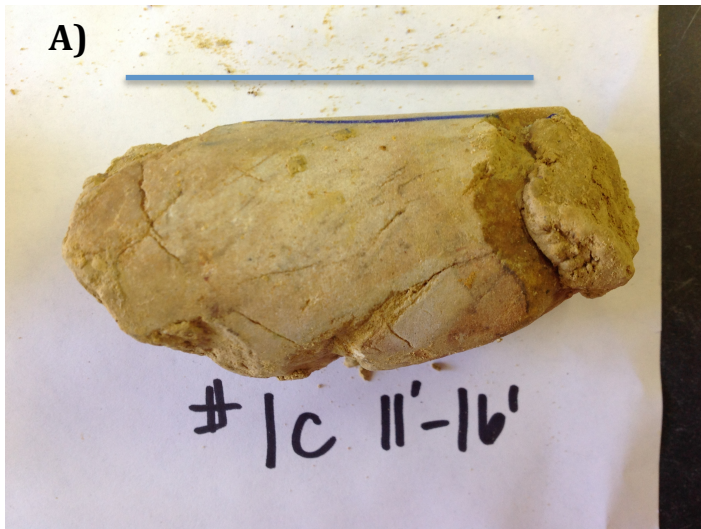
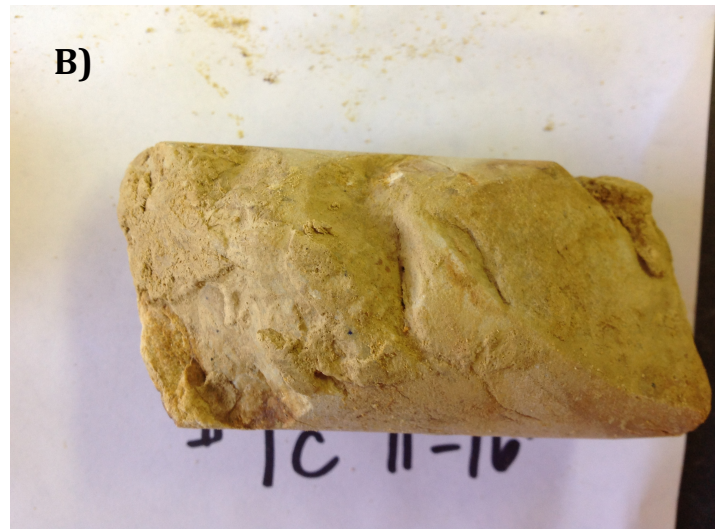
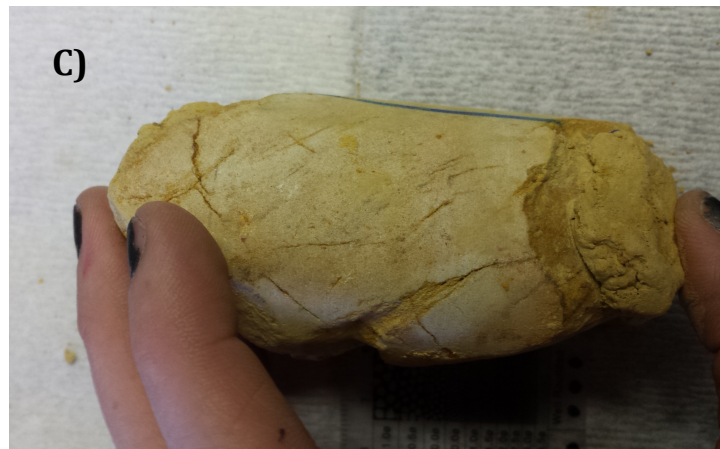
Run # 1c

Sample Description: Yellow/ beige to yellow orange in color. Some minor yellow to red/brown staining at top of core. Well cemented, well-sorted fu-FL grain size. Some 45° joint fractures (see image C) are observed. Blue line in Figure A is 8in. Top of core is to the left. Figure C, is the core after one week of drying

- 1d – Deeper than 1c. Yellow/ beige to yellow orange in color. Some minor yellow to red/brown staining at top of core. Well-cemented, well-sorted fu-fL grain size. Some 45° joint fractures (see image c) are observed.

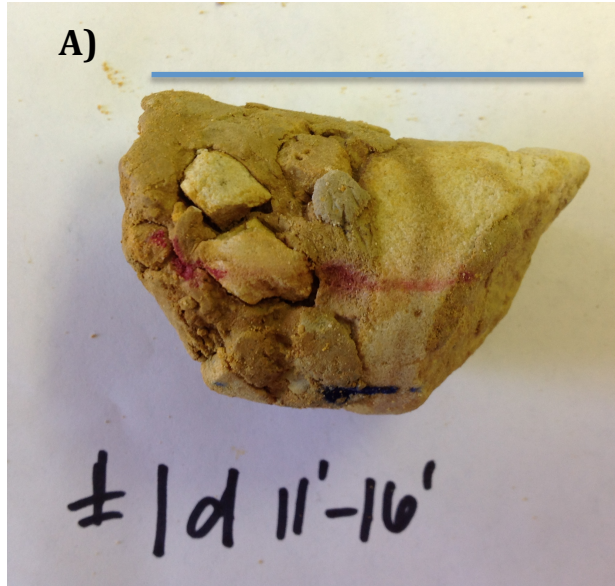
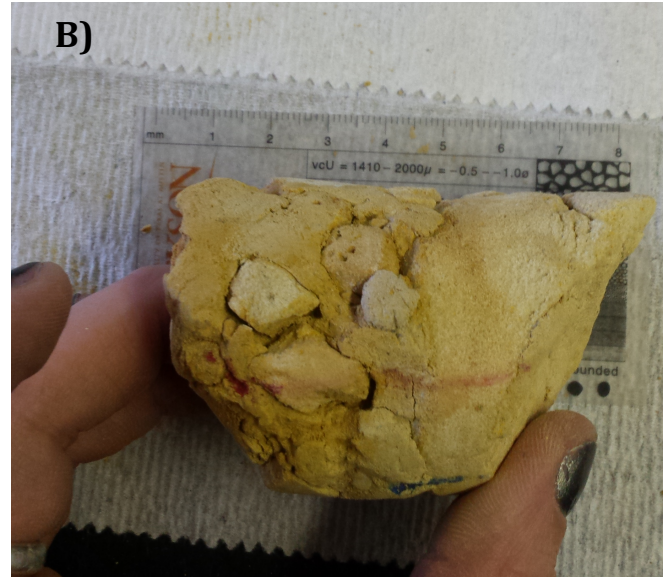
Run #1d

Sample Description: Sample different than previous. Not same well-cemented, well-sorted pure quartzite. Top of sample (imaged to the left) contains clasts 0.5-1 inches in diameter amongst sandy/clay mixture (mU grain size; 350-500 μ). Yellow/beige to light yellow/tan in color. Bottom of the core (right side of images) is more similar to other samples, cemented, well-sorted quartzite, but more friable. Noted some (~10 dissolution pits near top of the sample). Blue line in Figure A represents 7in. Figure B is after one week of drying; ruler is in inches.

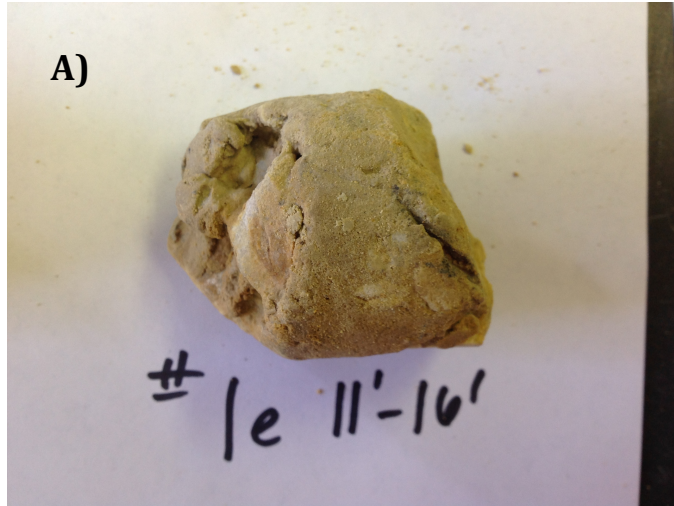
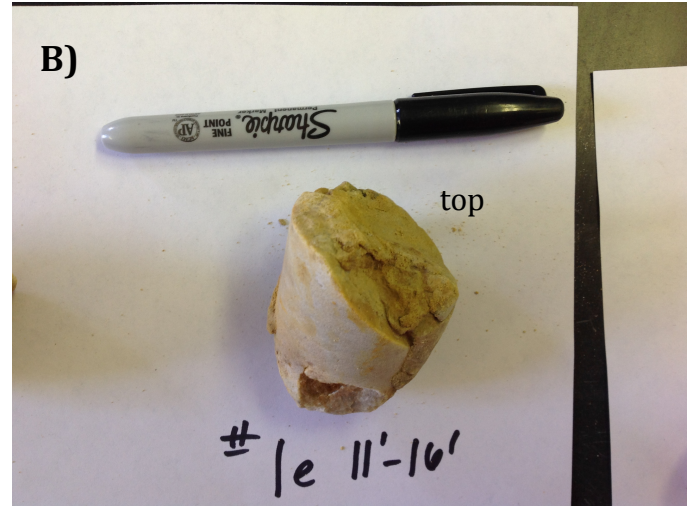
Run #1e

Sample Description: Grey/white to beige to color; minimal red-brown staining. Sand/clay mixture adhered to outside of sample. fU-mL grain size. Well-sorted and cemented.

- 1e – Deeper than 1d. Grey/white to beige to color; minimal red-brown staining. Sand/clay mixture adhered to outside of sample. fU-mL grain size. Well-sorted and cemented.

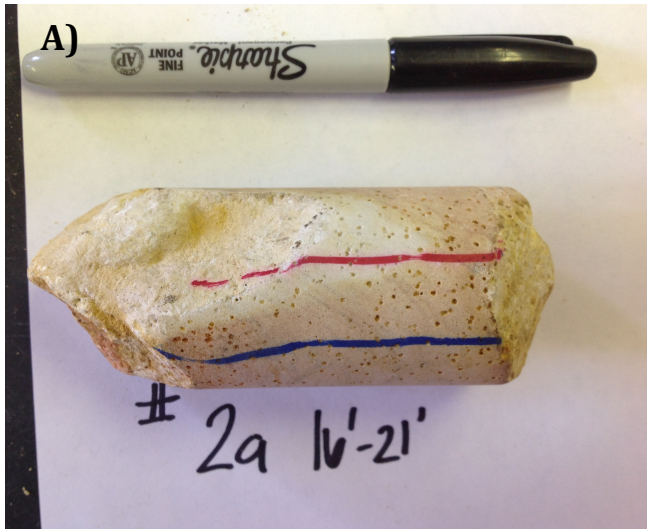
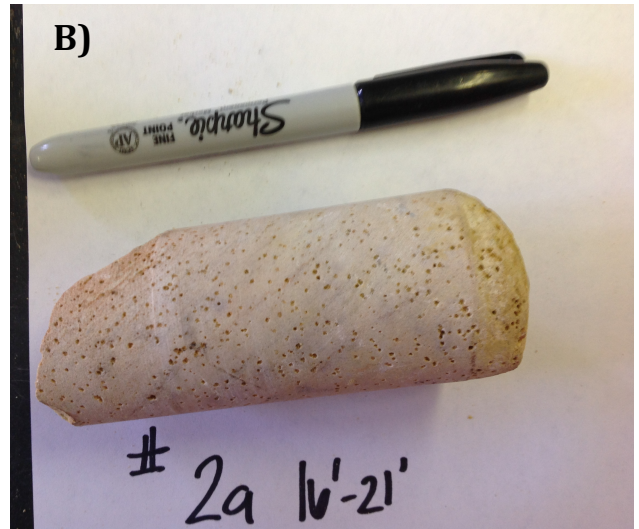
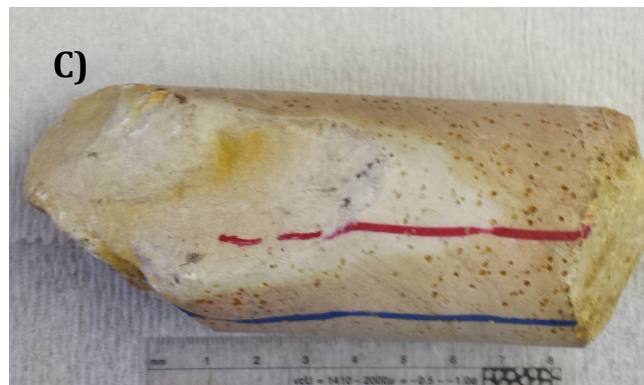
Run #2a

Sample Description: Pink/Rose to yellow/white in color. Zone of white discoloration (looks as if rose colored staining was removed). Extensive dissolution pits with red/brown staining. Similar features to previous samples. Well-sorted, cemented quartzite fU-mL grain size. Top of sample imaged to the left. Figure C is imaged after one week of drying, ruler in inches.

- 2a – Pink/Rose to yellow/white in color. Zone of white discoloration (looks as if rose colored staining was removed). Extensive dissolution pits with red/brown staining. Similar features to previous samples. Well-sorted, cemented quartzite.
- 2b – Yellow/beige in color, yellow/brown staining on top of sample. No dissolution features. Some layers. Grain size ranges from mU/mL to fU-mL; well-sorted. Some fracture along top could contain some clay particulate.
- 2c – Yellow/beige to white in color. Some fractures with yellow/red-brown coloration and potential clays; bottom yellow/brown in color. Some dissolution pits. Grain size ranges fU-mL; well-sorted.
- 2d - Yellow. White in color; some brick-red staining (surficial). Well-sorted and cemented with some dissolution pits. Grain size fU.

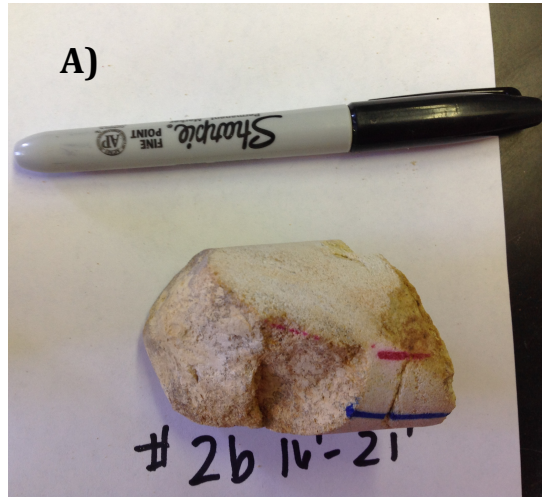
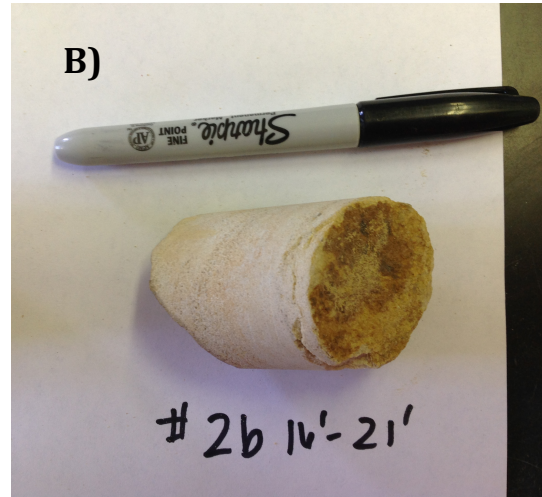
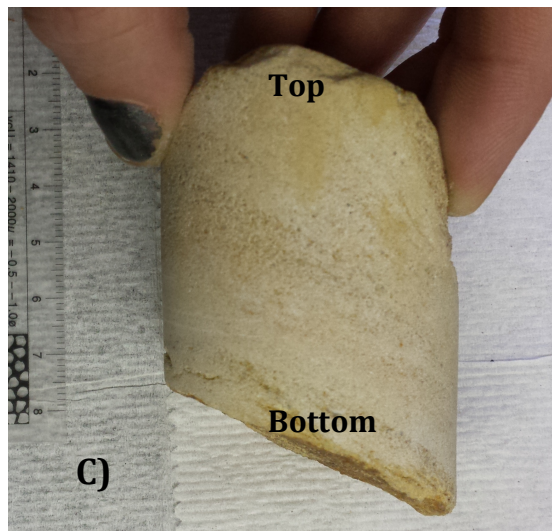
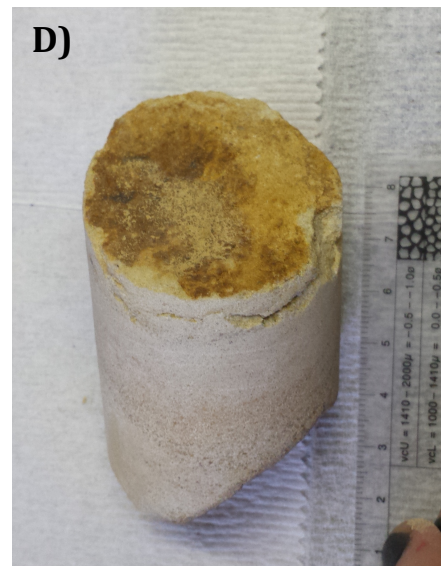
Run #2b

Sample Description: Yellow/beige in color, yellow/brown staining on bottom of sample (Figure D). No dissolution features. Some layers. Grain size ranges from mU/mL to fU-mL; well-sorted. Some fracture along top could contain some clay particulate. Figures C and D are after one week of drying; ruler is in inches.

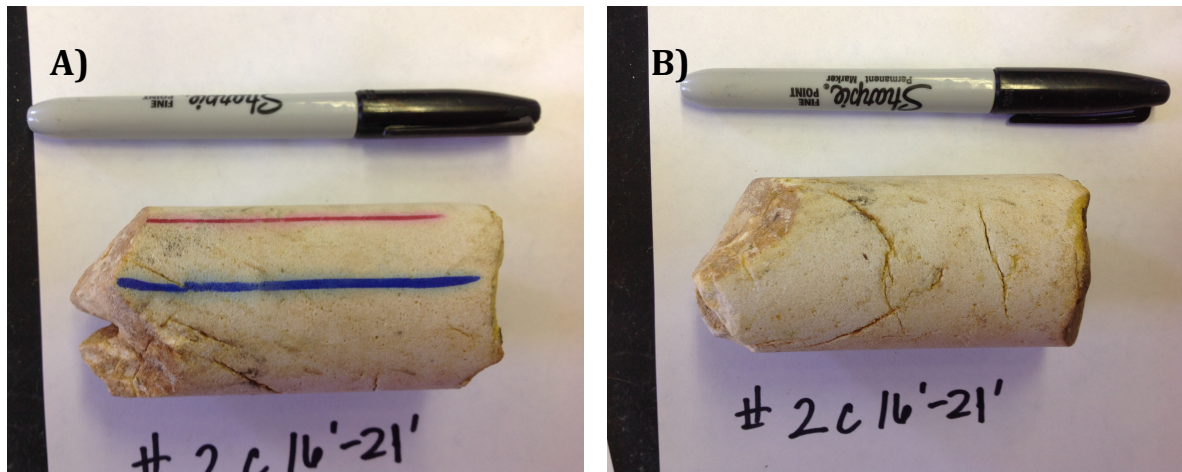
Run # 2c

Sample Description: Yellow/beige to white in color. Some fractures with yellow/red-brown coloration and potential clays; bottom yellow/brown in color. Some dissolution pits. Grain size ranges fU-mL; well-sorted. Top is orientated to the left, sharpie for scale.

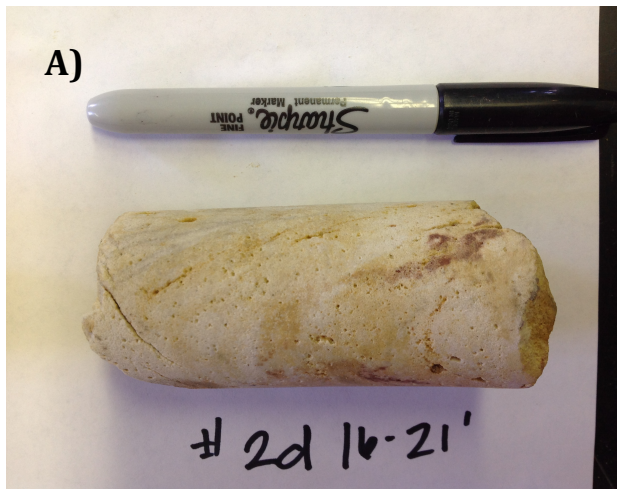
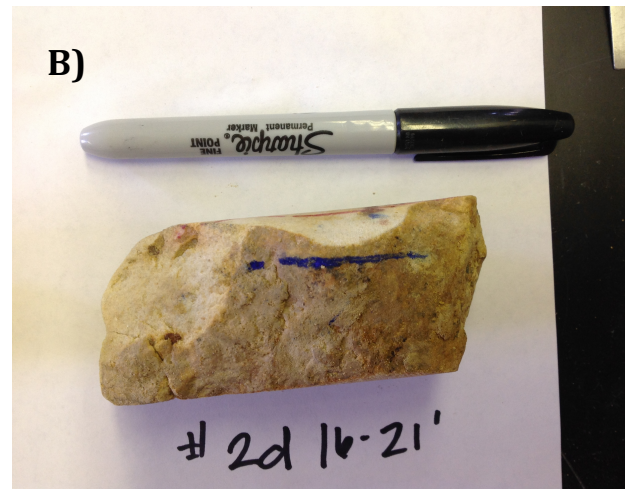
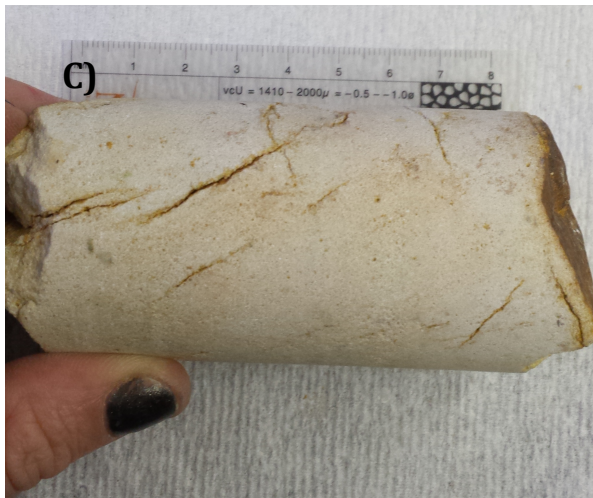
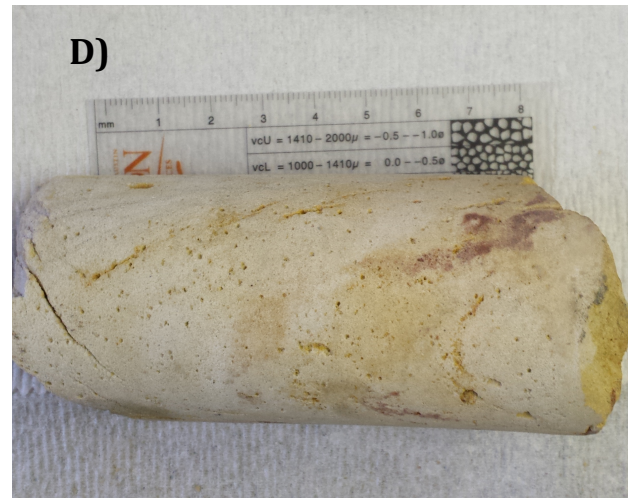
Run #2d

Sample Description: Yellow. White in color; some brick-red staining (surficial). Well-sorted and cemented with some dissolution pits. Grain size fU. Top is oriented to the left; ruler is in inches. Figures C and D are after drying for one week.
